# **Navajo Abandoned Uranium Mine**

## **Site Screen Report**

**Mine Name: Utah No. 1 Lease  
Mine ID: 706**

**April 2012**

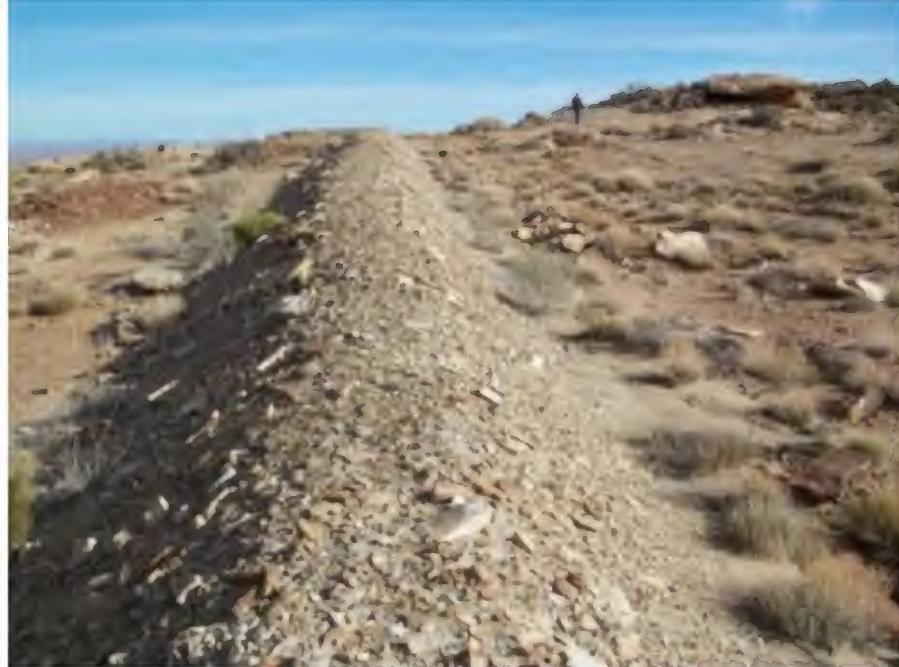
**Photo 1**

Mine Site #706 - Berm

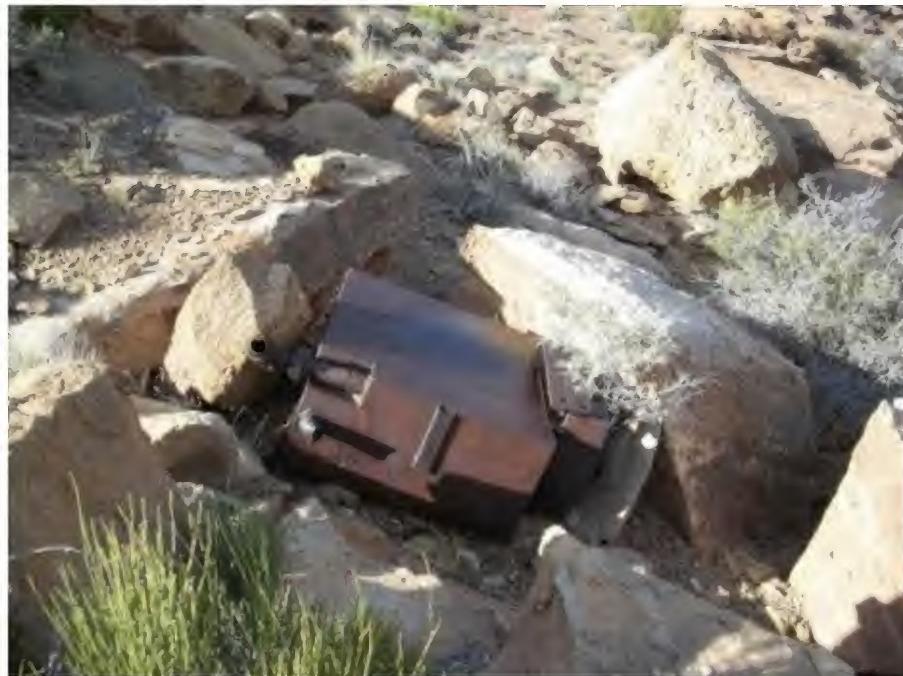
**Photo 7**

Exploration holes; derilict mine equipment

Mine Site #706 – Mining debris

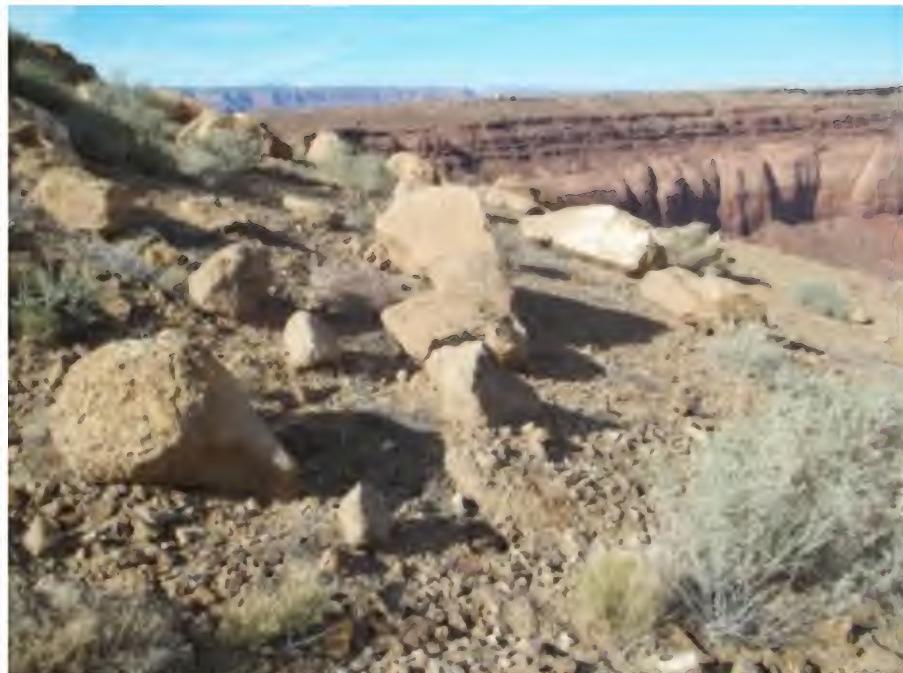
**Photo 8**

Waste pile in the southern part of the site, near the top along the bench (just below resistant, course sand/gravel unit), the pile appears to continue offsite, towards the west

Mine Site #706 – Waste rock
